# FRC ON-SITE AIR BAG DEPLOYMENT INVESTIGATION

CASE NO. 90-5

FLEET - 1989 DODGE DAYTONA

LOCATION - NJ

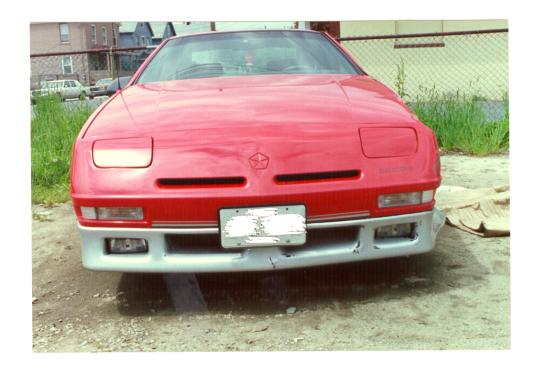
Frontal View Of The Dodge Daytona.

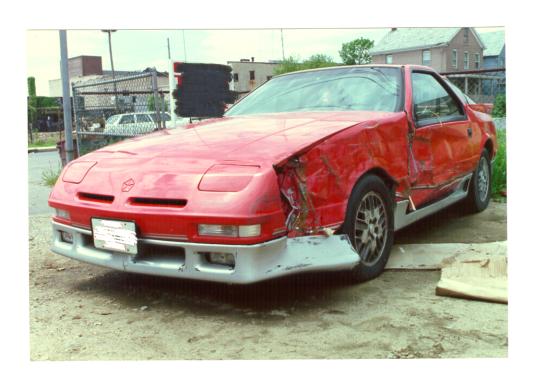
Left Front Three-Quarter View.

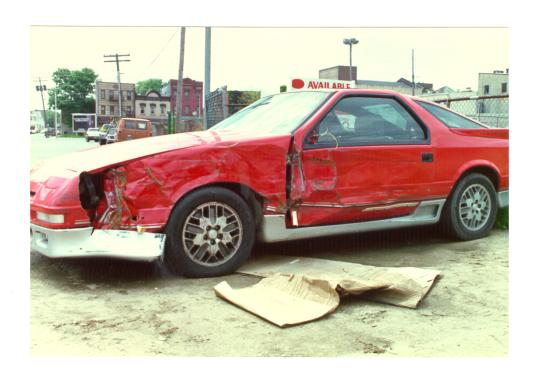
Daytona sustained moderate damage from its sideswipe type impact sequence with vehicle #2. Initial contact involved the extreme left front corner of the bumper facia, outboard of the bumper reinforcement bar. facia was displaced both rearward and laterally to the vehicle's right which allowed the leading edge of the left front fender to engage with vehicle #2 resulting in 7" of crush located at the fender's leading edge. The left bumper energy absorbing device (EAD) compressed 0.125" then returned to its original position. Direct contact damage on the frontal plane began 26.9" left of the vehicle's centerline and extended 0.875" to the corner of the bumper facia. Direct damage also extended 122" down the left side of the vehicle ending at the leading edge of the left rear wheel opening. Crush values could not be measured across the frontal plane due to the narrow contact width; therefore, a set of crush values were measured at the mid-door level of the left side surface. The C-measurements over the 122" direct contact length were as follows:  $C_1=0.1$ ",  $C_2=0.5$ ",  $C_3=2.5$ ",  $C_4=3.2$ ",  $C_5=1.5$ ",  $C_6=2.2$ ".

Left Side View Of The Vehicle's Damage.

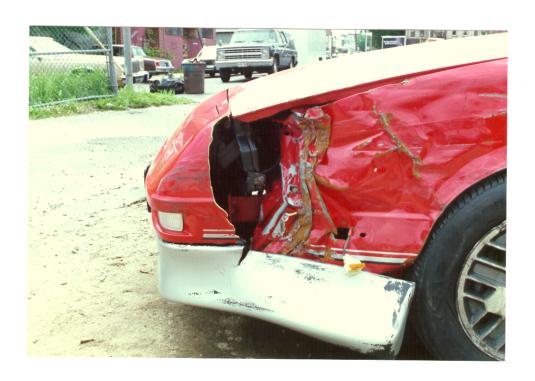
Close-up View Of The Displacement Of The Leading Edge Of The Left Front Fender.

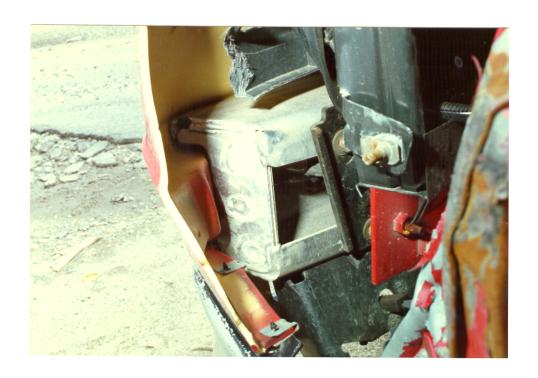
Left Corner Of The Front Bumper Reinforcement Bar.

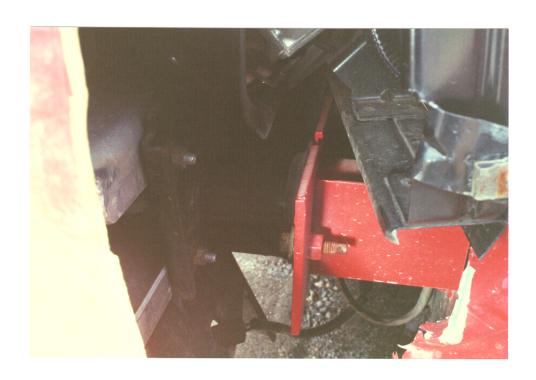
Both vehicles sustained moderate sideswipe type damage that began on the extreme left corner of the frontal plane and extended down the entire left side (CDCs of 12-FLES-9). The endura bumper facia of the Daytona compressed laterally which allowed the leading edge of the left front fender to contact the Toyota, resulting in 7" of rearward displacement of the fender edge. There was no front bumper reinforcement bar damage; however, the left bumper energy absorbing device compressed .125" and returned to its original position.

Left Front Bumper Energy Absorbing Device.

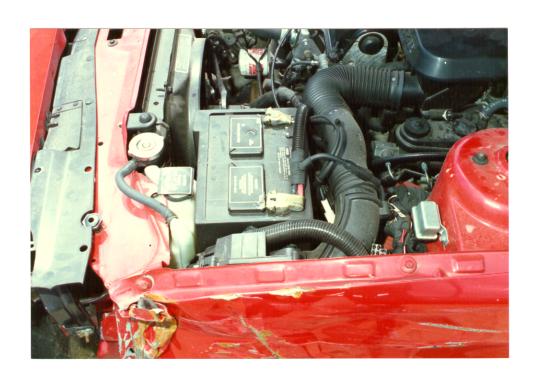
Area Of The Left Front Crash Sensor.

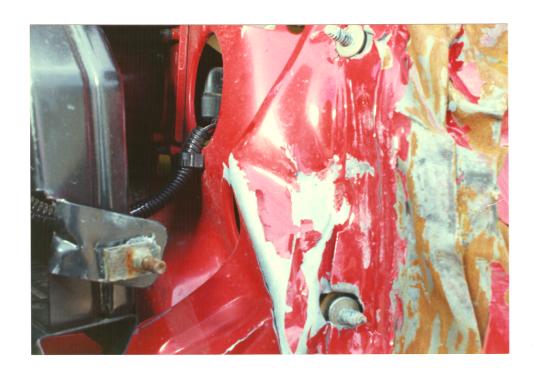
Left Front Crash Sensor.

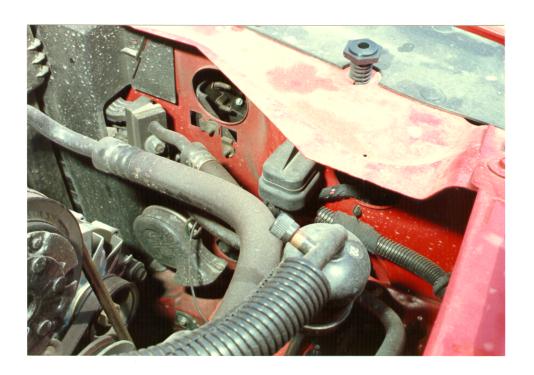
Right Front Crash Sensor.

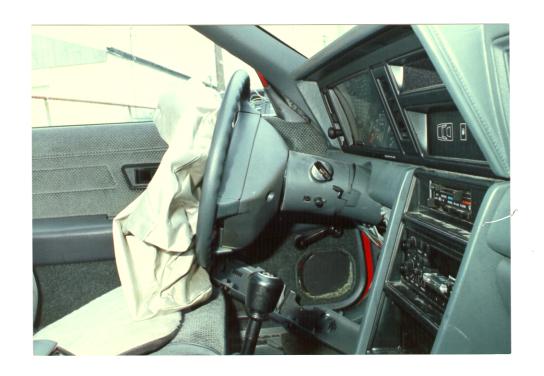
The interior of the air bag vehicle sustained minor damage that was associated solely with occupant loading. The driver's involvement with the steering assembly resulted in deformation of the spoke flange. The left upper quadrant of the steering wheel rim was displaced approximately 1" forward due to the spoke flange deformation. Her loading force also compressed the energy absorbing steering column 1.6" with 1.1" of left shear capsule separation.

Steering Wheel Deformation And Column Compression That Resulted From Occupant Loading.

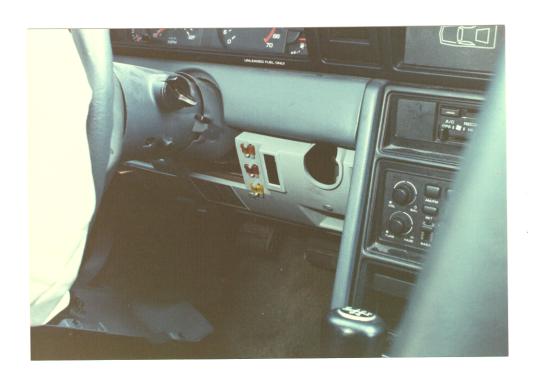
Knee Bolster Reinforcement; No Damage.

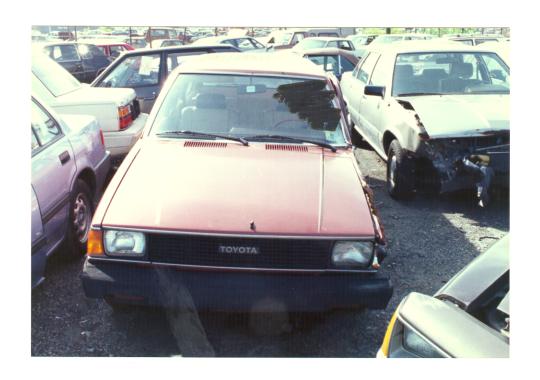
Vehicle #2 also sustained moderate damage from its involvement with the air bag vehicle. Direct frontal contact was 2.5" located at the left front bumper corner and turn signal assembly. Due to the minimal frontal contact, the left side of the Toyota engaged with the side of the Daytona resulting in 163.25" of direct contact damage which extended down the entire left side of the vehicle.

Frontal View Of Vehicle #2.

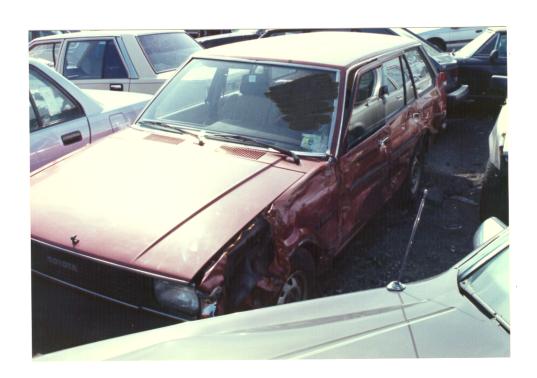
Left Front Three-Quarter View.

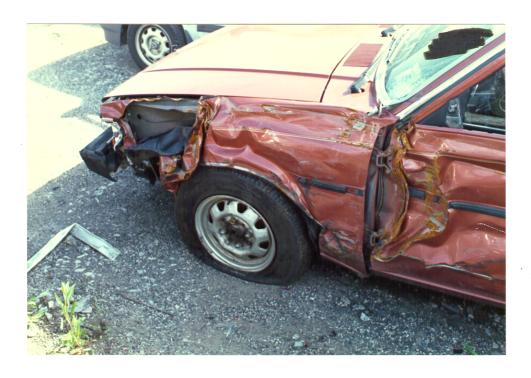
Rearward Displacement Of The Leading Edge Of The Left Front Fender and Door.

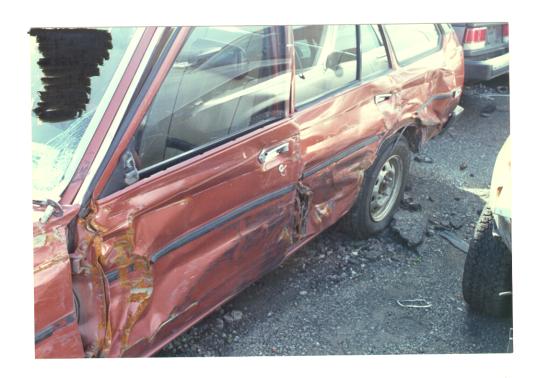
Damaged components included the front bumper covering, the left turn signal assembly, left front fender, both left doors, left Apillar, windshield, and the left rear quarter panel.

Sideswipe Damage Extends To Rear Of Vehicle.
